Manhole Inspection Summary

Manhole # S61I__025MH

Insp Date: **3/24/08 10:51 AM**

Location Address: **501Savage St.**

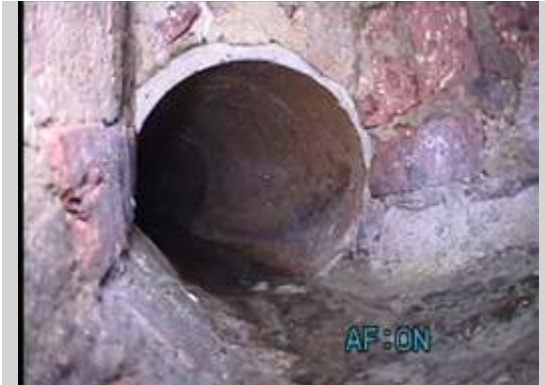
12 O'Clock Outflow

8 in. Circular Gravity Sewer
Pipe Out @ 12 O'Clock

Pipe Height: **8.4** (in.) Rod and Bar (Angled)
Pipe Material: **Clay** ☐ Pipe Lined
Invert Depth: **8.63** (ft.) Flow Characteristics: **Slow**
Deposits: ☒ None ☐ Mud ☐ Sludge ☐ Debris ☐ Grease
Silt Depth: (in.) Deposits Extent:
Infiltration: **None** Pipe Seal Cond: **Sound**

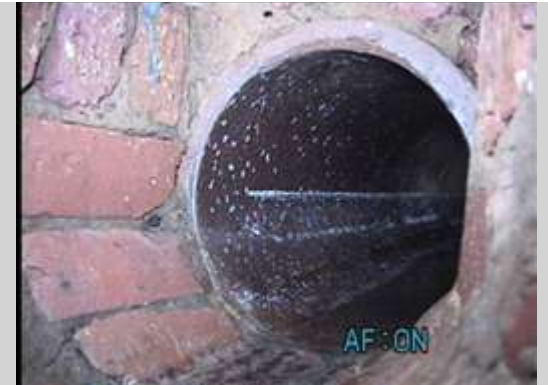
9 O'Clock Inflow

8 in. Circular Gravity Sewer

Pipe In @ 9 O'Clock

Pipe Height: **8.4** (in.) Rod and Bar (Angled)

Pipe Material: **Clay** ☐ Pipe Lined

Infiltration: **None** Pipe Seal Cond: **Sound**
